**ENVIRONMENTAL ENDURANCE TESTING OF AN
ELASTOMERIC PITCH CHANGE BEARING**

Lord Kinematics

**Army Air Mobility Research and Development
Laboratory**

USAAMRDL TECHNICAL REPORT 72-73

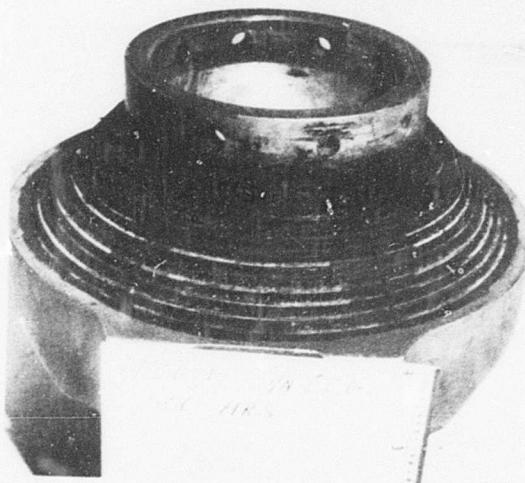
The progression of failure of test sample 5 is shown in Figures 47 through 58. The appearance of this sample was typical of all samples tested. A slight amount of elastomer abrasion is visible in the innermost sections of the bearing in Figure 48. The gummy appearance of the elastomer in Figures 49 and 50 is a result of accidental exposure to test machine oil. The abrasion is quite heavy at the 800-hour level shown in Figure 52. All elastomer sections are abrading elastomer at the 1200-hour level as shown in Figures 55 and 56. Voids are visible in several sections of the failed bearing at 1400 hours, and several large pieces of elastomer have extruded from the small end of the sample.

Figure 50. Test Sample 5
(S/N 006) at 500
Hours.

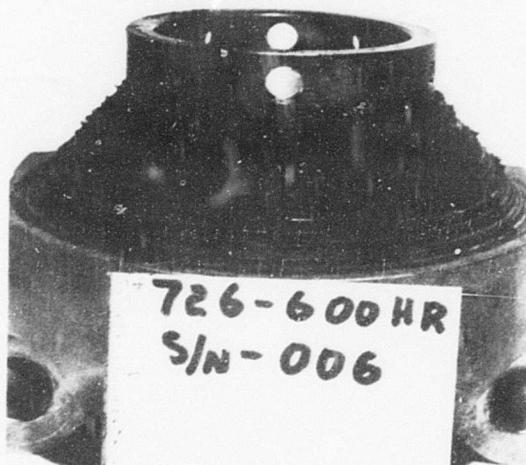
Figure 51. Test Sample 5
(S/N 006) at 600
Hours.

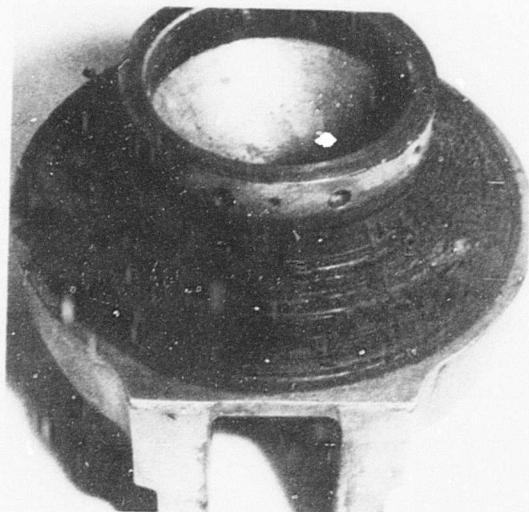
Figure 57. Inboard View of Test Sample 5
(S/N 006) at 1400 Hours.

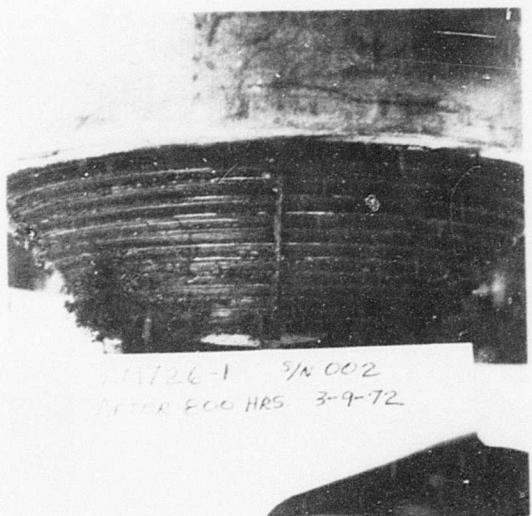
The "hair-like" abrasion typical of the early failure stages is shown in Figure 59. This is a view of test sample 2 looking at 90 degrees to the radial load. Test sample 3 is shown in the sand and dust chamber in Figure 60. Its appearance when cleaned was similar to the remaining samples.

Figure 59. Abrasion of Test Sample 2 (S/N 002) at 800 Hours.

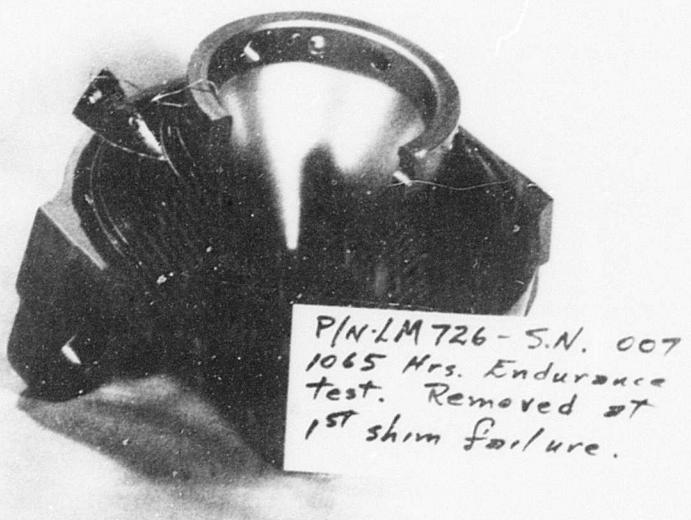
Figure 62. Sectioned View of Test Sample 6 (S/N 007) After Failure at 1065 Hours.

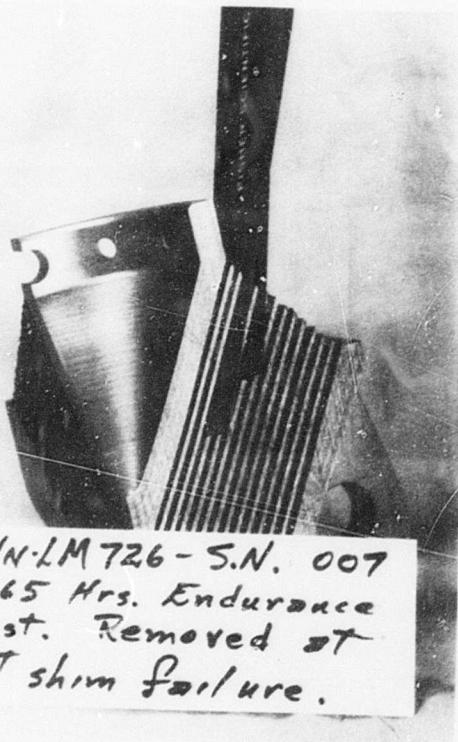
Test sample 3 after failure at 800 hours is shown in Figure 61. Failure was a shearing of the elastomer in section one resulting in a complete separation of the inner member. At this point in the endurance test, deterioration was primarily in the inner six sections. A sectioned view of test sample 6, in Figure 62, illustrates the elastomer sections voids and the cracked shim. Figure 63 clearly illustrates the voids in sections one and five.

Figure 63. Test Sample 6 Showing Depth of Elastomer Loss.
